VEHICLE ENGINEERING

STS-104 FLIGHT READINESS REVIEW

Presenter:
	Organization/Date: Orbiter/06-28-01

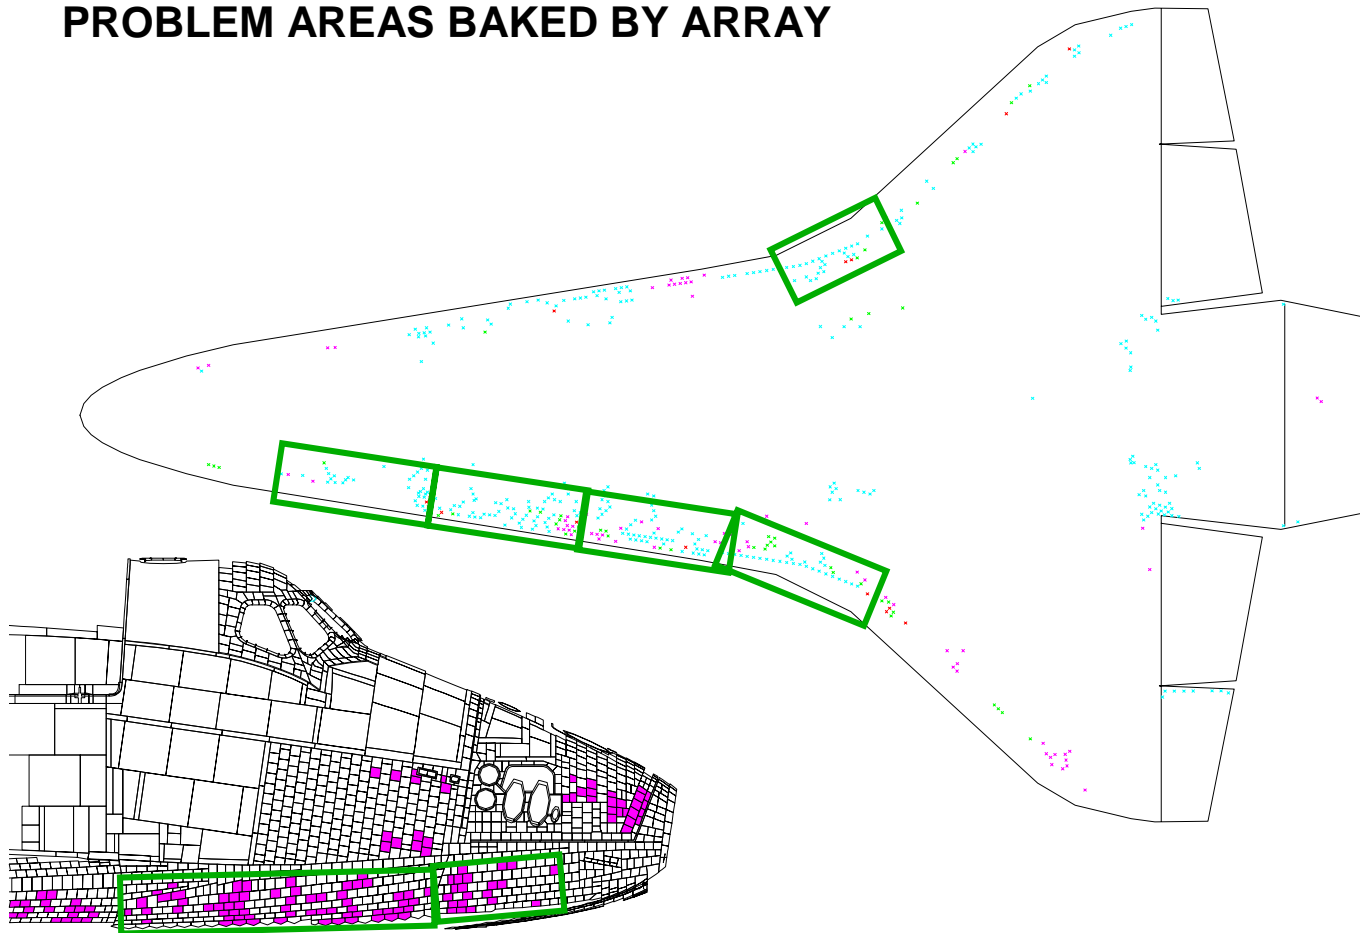
PROBLEM AREAS BAKED BY ARRAY

- 1985 NASA test program developed tile fracture threshold for temperature vs. water content
 - Showed that less than 20% water in a tile will not result in a fracture at any temperature
- PRT concluded that the baking protocol used dries the tile to well below the 20% limit from the 1985 testing
- Additional lab testing characterized tile rewaterproofing when a small amount of water remains
 - With an initial 15% water content, test tile successfully accepted waterproofing with three waterproofing applications and a total of 8cc DMES applied
 - Verified by water repel test of a dissected lab sample and supported by successful water repel test performed on five cored sections removed from OV-104 “problem” tiles
 - Application of DMES drives out additional water
- Verified all tiles which were baked received the required waterproofing protocol

- TPS tiles are criticality 1/1
 - Risk of tile damage/loss was eliminated by drying the tile for a minimum of 4 hours or until no visible water was escaping from the tile
 - Ensures water content is below the threshold where on-orbit freezing is a concern
 - Special waterproofing protocol ensures baked tiles are fully waterproofed

- All OV-104 tiles have been dried and rewaterproofed
 - All wet tiles either dried naturally or were baked a minimum of four hours or until no visible water was escaping
 - Lab testing verified the drying time conservatively protects from potential damage due to freezing
 - Lab and on-vehicle core samples verify tile was successfully rewaterproofed

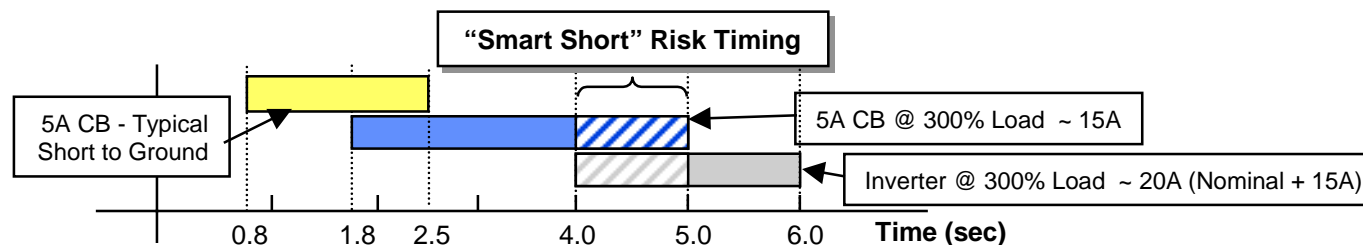
RADIATOR ISOLATION VALVE CIRCUIT BREAKERS ON PANEL L4

- The maximum current allowed by a 5 amp circuit breaker could cause an over-current shutdown of the associated inverter if a short in the circuit were to occur

- Circuit stress analysis verified wire is protected under present conditions
- Panel L4 wiring was inspected as part of hinged panel wire inspections - no discrepancies were found
- The OV-104 radiator isolation valves have been cycled to verify circuit integrity
- With a typical short to ground, the 5 amp circuit breaker will protect the circuit
 - A “smart short” (a limited current short that allows the inverter to overload before the circuit breaker trips) could result in an over-current shutdown of the inverter

- Since power to an isolation valve is only applied downstream of panel L2A1 in a contingency situation, exposure to risk of a short circuit is limited
- In the event an isolation valve must be closed, the 5 amp circuit breaker will protect for the most common short circuit condition
- For a “smart short” overload trip of the upstream inverter, flight rules require the circuit breakers for all downstream circuits to be opened resulting in loss of redundancy in multiple PLBD latch gangs
 - There is an existing IFM procedure which would isolate the shorted inverter and allow the 3-phase ganged circuit breakers to be closed restoring redundancy to PLBD latch functions on the remaining two phases
 - If these functions cannot be recovered by the IFM, the flight rules require a next PLS due to loss of PLBD function redundancy

- The functionality and integrity of the OV-104 radiator isolation valve circuits have been verified
- Exposure to risk is limited to contingency radiator isolation
- Under most short circuit conditions, the 5 amp circuit breaker will protect the circuit
- If the inverter is shutdown as a result of a “smart short”, an IFM procedure is in place to restore PLBD function redundancy

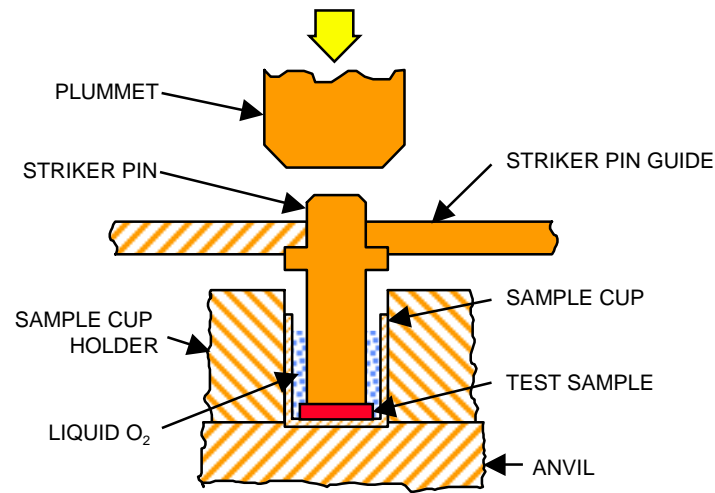
MPS/PRSD CRYO SKID TEST STAND OIL CONTAMINATION

- Performed analysis of contaminant
 - Determined to be double distilled pure hydrocarbon oil with paraffin from vacuum pump on test skid
- Evaluation of test stand configuration revealed a mechanism for oil migration to test articles
 - Pump seal leakage/back diffusion allows introduction of oil into vacuum lines
 - MPS Prevalve ATP exposes flight valve and LN₂ supply system to vacuum source providing path for oil migration
 - Subsequent testing of PRSD panels and MPS Fill and Drain valves exposes test articles to accumulated oil

- Performed oxygen/ignition testing at WSTF to characterize volatility of vacuum pump oil in LOX and GOX
 - LOX ignition threshold is >10 ft-lbs impact on 2 mg oil
 - 2 mg oil equates to 778 mg/ft² concentration
- Oil passed 1050 psi GOX mechanical impact testing at 30 ft-lbs impact on 2 mg oil

- Development of cleaning procedure
- Vacuum pump and test configuration evaluation will be performed to determine leakage path and specific transport mechanism
- Other NSLD vacuum applications have been evaluated – no other test configuration exposes LOX hardware to vacuum oil
 - Evaluation in work to determine if any other hardware is at risk due to vacuum pump oil
- Communication with vendors to evaluate potential for similar contamination

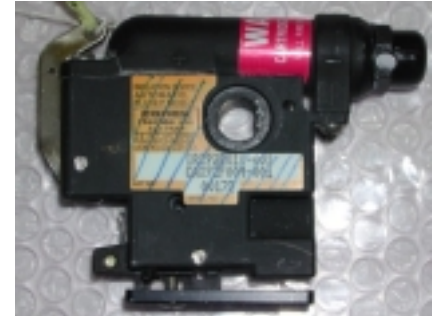
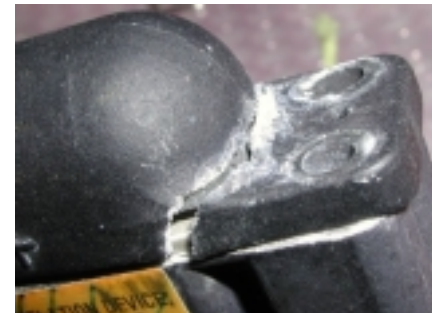
- FLU-9 is a pyrotechnic device installed on the life raft
- Pyro is automatically activated upon water entry to partially inflate the Crew Escape life raft by puncturing 1 CO2 cylinder (life raft is fully inflated by manually activating a second CO2 cylinder)
- Upon water entry during training 1 unit fired improperly
 - Pyro discharged but failed to puncture CO2 bottle
 - External housing cracked and vented to ambient
- During testing at the vendor of 1997 lot flight units to assess this failure, 2 additional units fired inadvertently
 - 1 unit during bleed resistor testing (S/N 234)
 - 1 unit during Electro Static Discharge (ESD) testing (S/N 236)
- Although no failures have been seen with FLU-8 devices (pyros used in the life preserver unit), similarity to the FLU-9s make them subject to the same issues

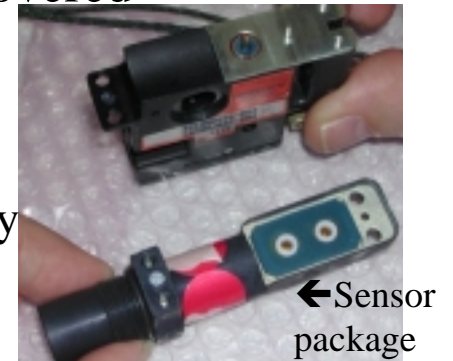
- Contact provided a path allowing failure of the unit during ESD testing
- Additional analysis is being performed
 - Investigating failure paths of the electronics sensor housing

- Determining if static discharge is a credible failure in Crew Escape applications
